Lauda Air B767 Accident Report

**AIRCRAFT ACCIDENT INVESTIGATION COMMITTEE
MINISTRY OF TRANSPORT AND COMMUNICATIONS
THAILAND**

**LAUDA AIR LUFFFAHRT AKTIENGESELLSCHAFT
BOEING 767-300ER
REGISTRATION OE-LAV**

**DAN CHANG DISTRICT
SUPHAN BURI PROVINCE
THAILAND
26 MAY B.E. 2534 (A.D. 1991)**

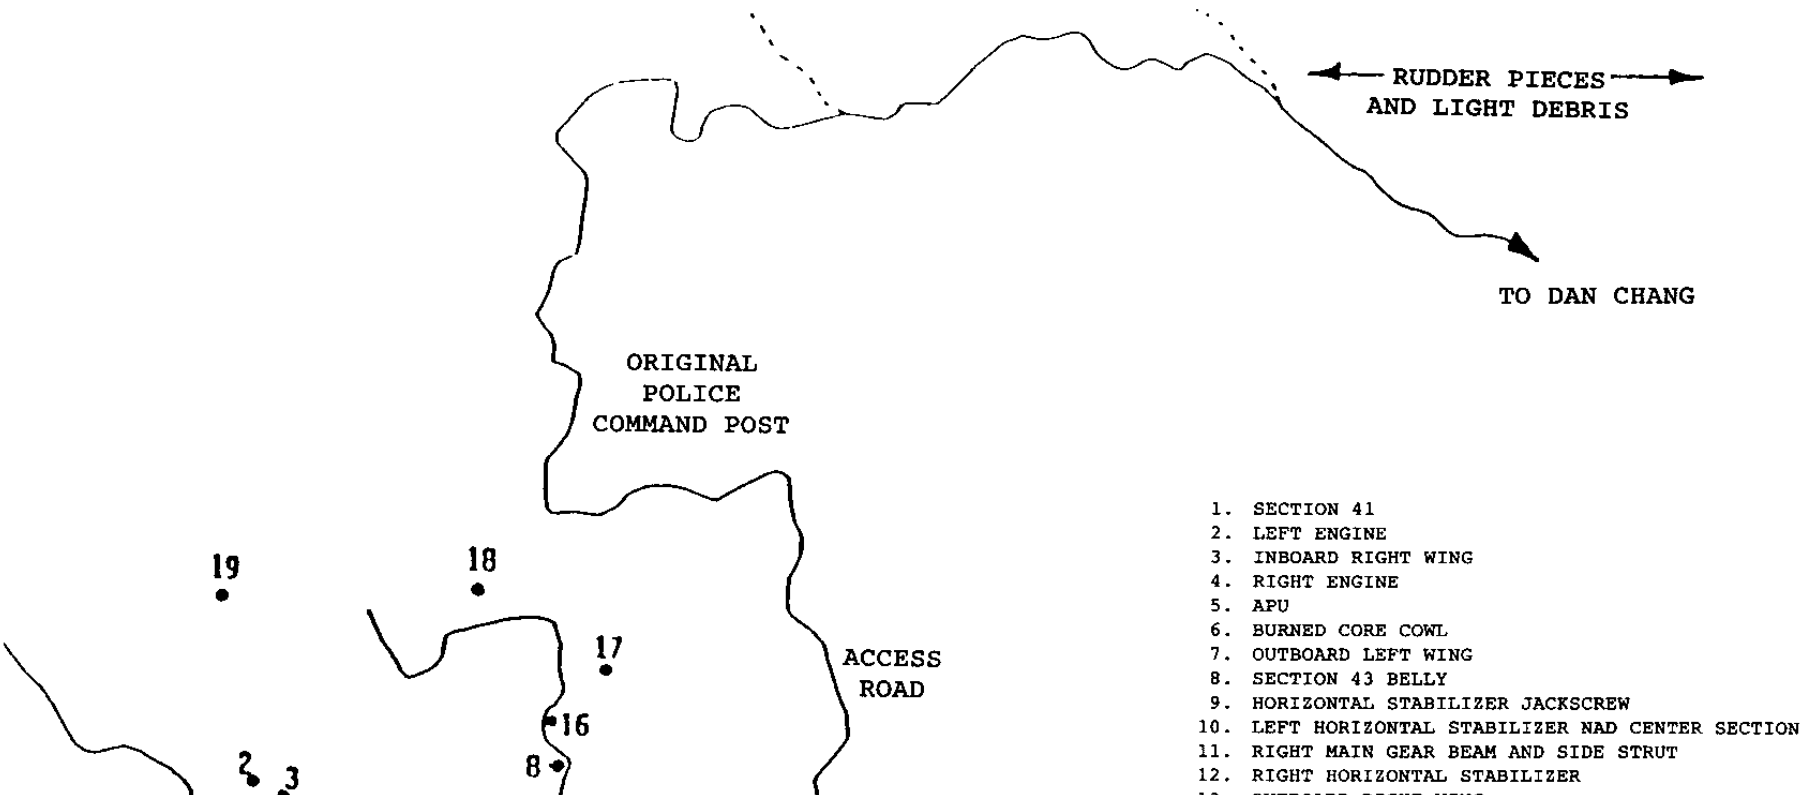
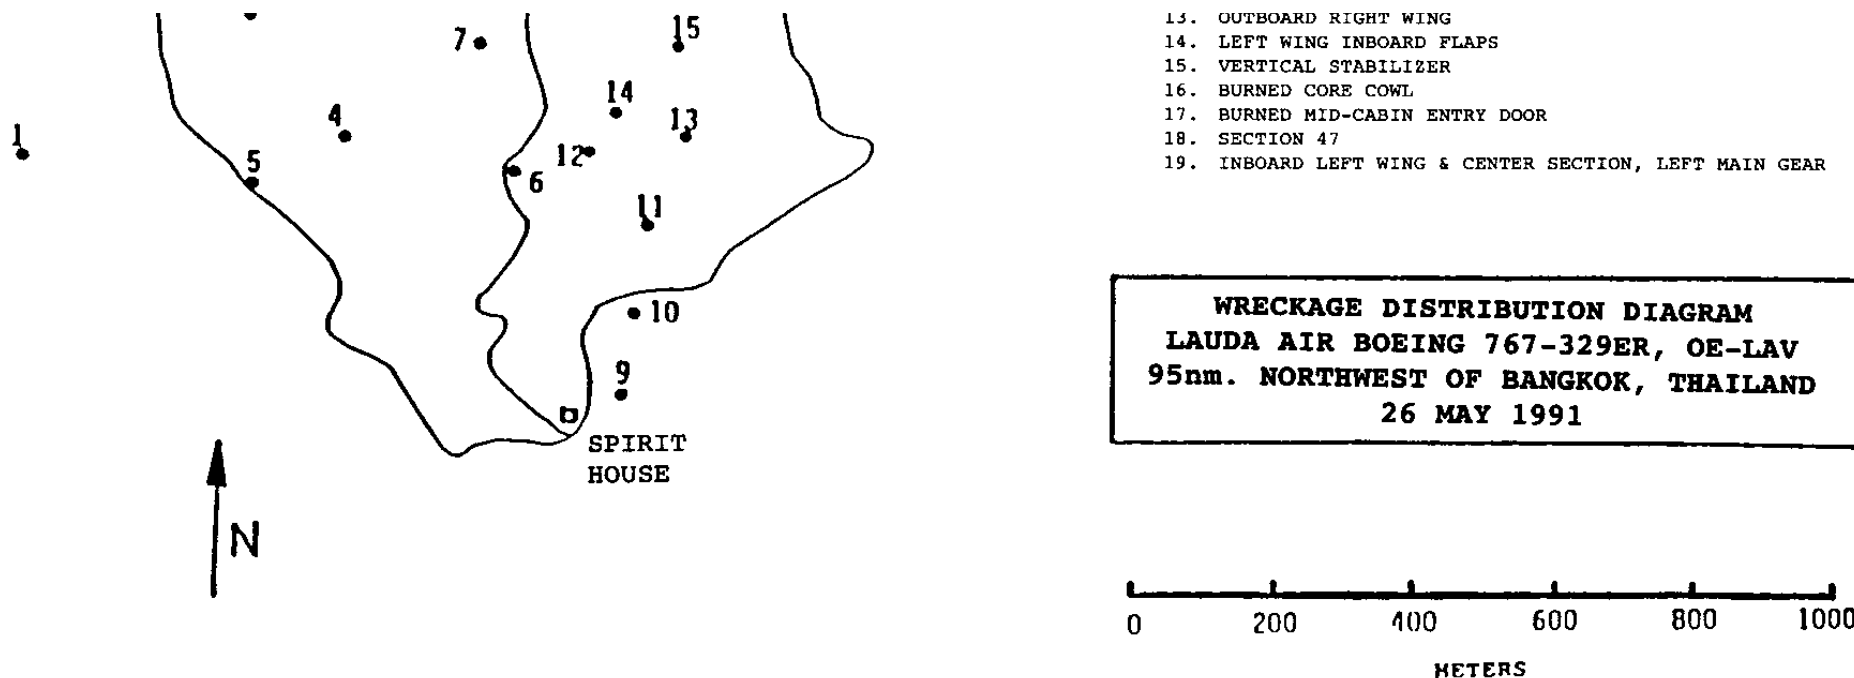
APPENDIX B
Wreckage Distribution Diagram

Most of the wreckage was found in a one square kilometer area, but some lighter weight components were found up to 2,000 metres from the initial impact point. The horizontal stabilizer was the first major component found in the debris pattern, which was along a generally northwest/southeast track. Thrust reverser actuators from the left engine (both sleeves) were found in the fully deployed position. A diagram of the wreckage spread is included in this report as [Appendix B](#).

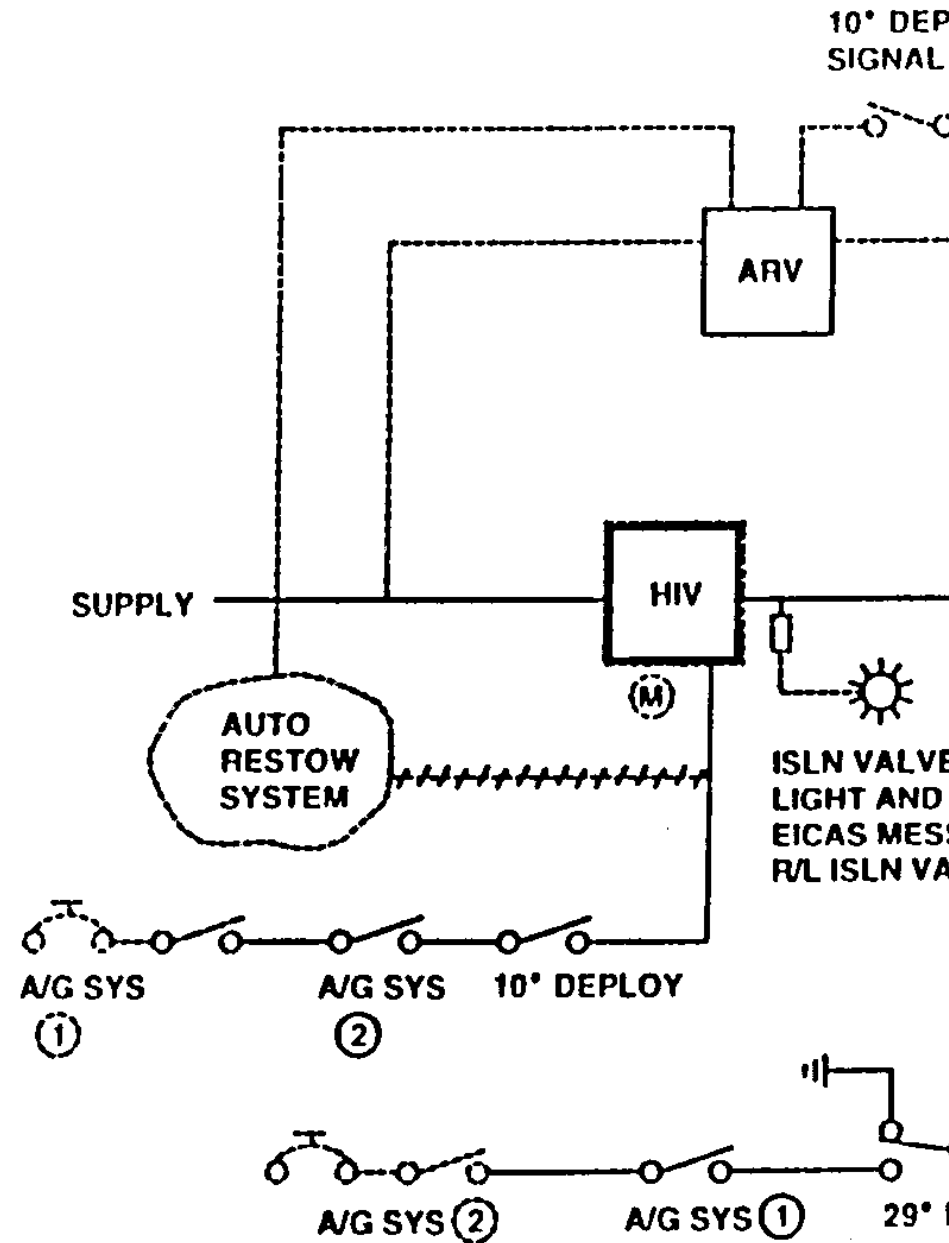
DIAGRAM 767 PW 4000 THRUST REVERSER OF CURRENT/NEW SYSTEM

The original design of the B767/PW4000 thrust reverser system required multiple failures for the reverser to deploy in-flight. The changes listed above for the B767 thrust reverser system address each of possible failure modes identified as a

result of the investigation. The design changes effectively should prevent in-flight deployment even from multiple failures. A diagram of the current (at the time of the accident) and new thrust reverse system is included in this report as [appendix F](#).
